October 22, 1999

TRIP REPORT

SITE NAME AND LOCATION: General Motors
3900 Motors Industrial Way
Doraville, Georgia 30360-3163
EPA I.D. No. GAD003310810

REFERENCES: Compliance Evaluation Inspection (CEI)

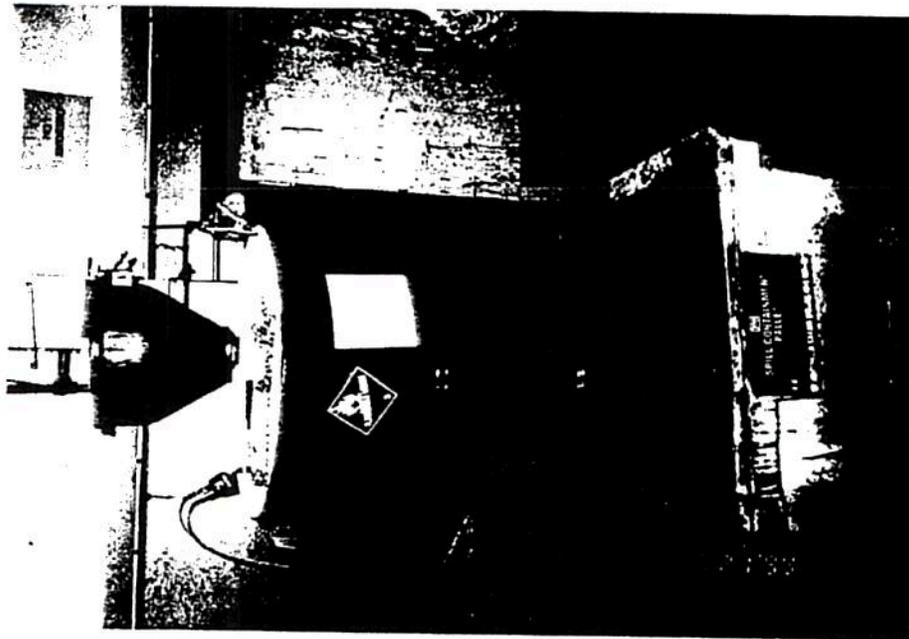
NO. 1 OF 9

EXPLANATION: Satellite accumulation drum for the spray booth touch-up bays.

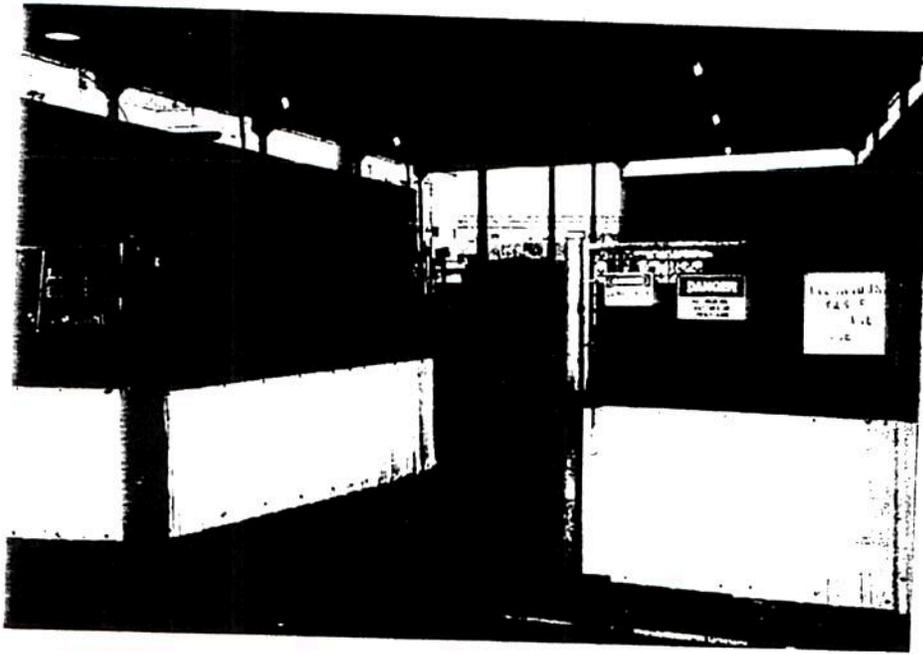
NO. 3 OF 9

EXPLANATION: Hazardous waste less than 90 day accumulation area.

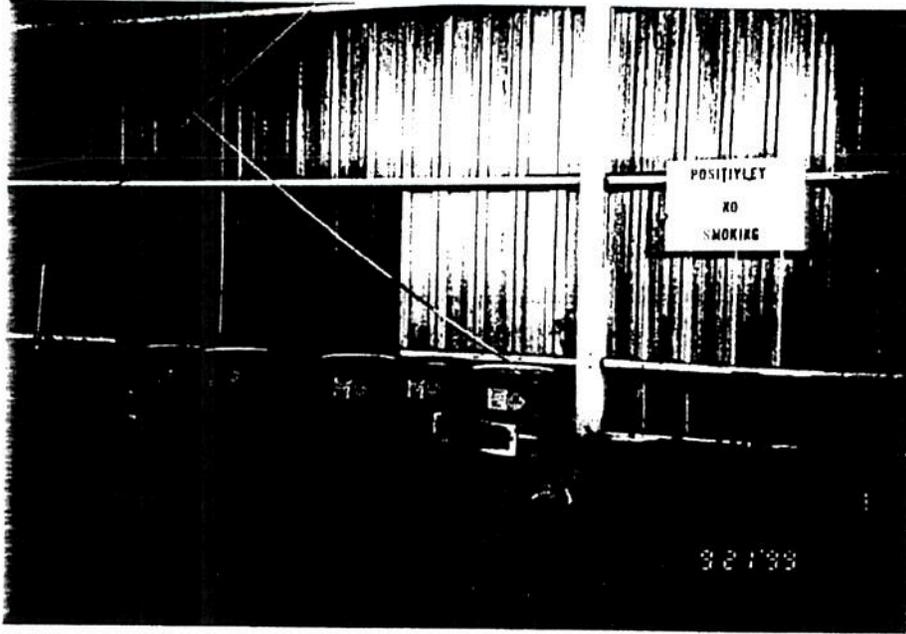
NO. 5 OF 9

EXPLANATION: Hazardous waste accumulation area. Waste solvent / paint related material is in the drums.

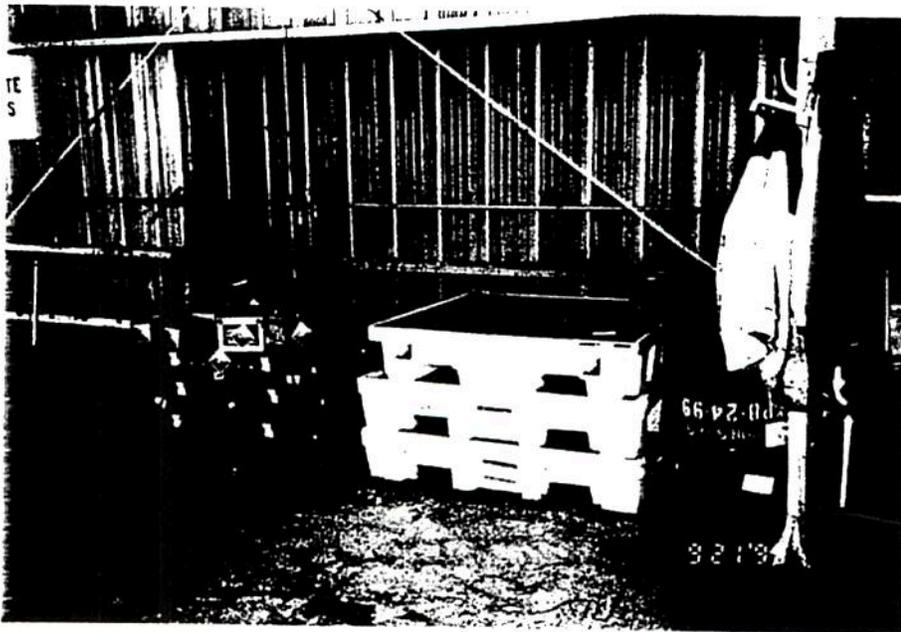
NO. 6 OF 9

EXPLANATION: Hazardous waste accumulation area. Waste lead acid batteries are accumulated on the spill contained pallets.

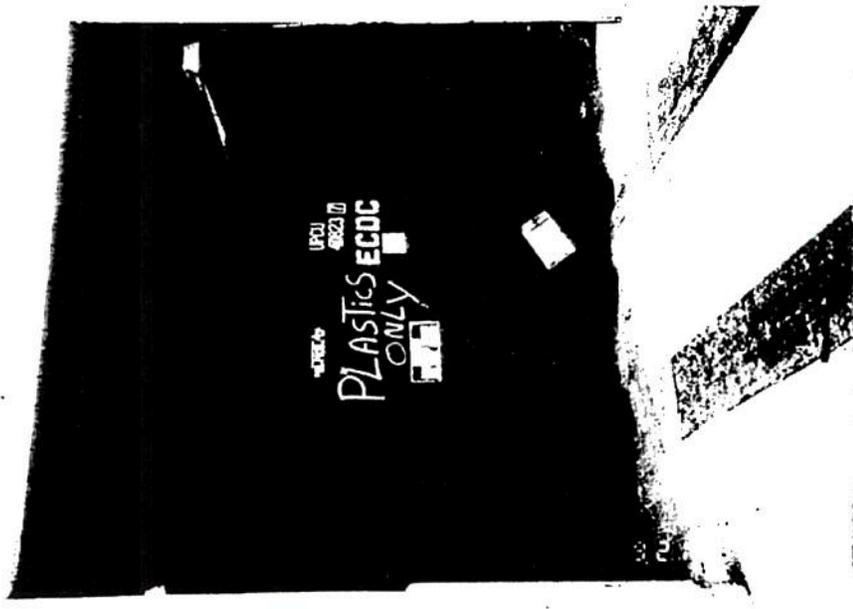
COUNTY:
Dekalb
NO. 9 OF 9
SITE NAME:
GM - Doraville
DATE: 9/21/99
PHOTO BY:
Ken Grall

The wastewater treatment sludge is listed as a F019 waste due to the chemical conversion coating of the aluminum vehicle hoods. This waste is generated at the wastewater treatment plant and is accumulated in a 30 yd³ rolloff container. GM was in the process of installing a new filter press that will dewater the sludge more efficiently.

EXPLANATION: F019 sludge is accumulated in this container.
